Boiler Safety Bulletin

Calif
Industrial Accident Commission

State of California

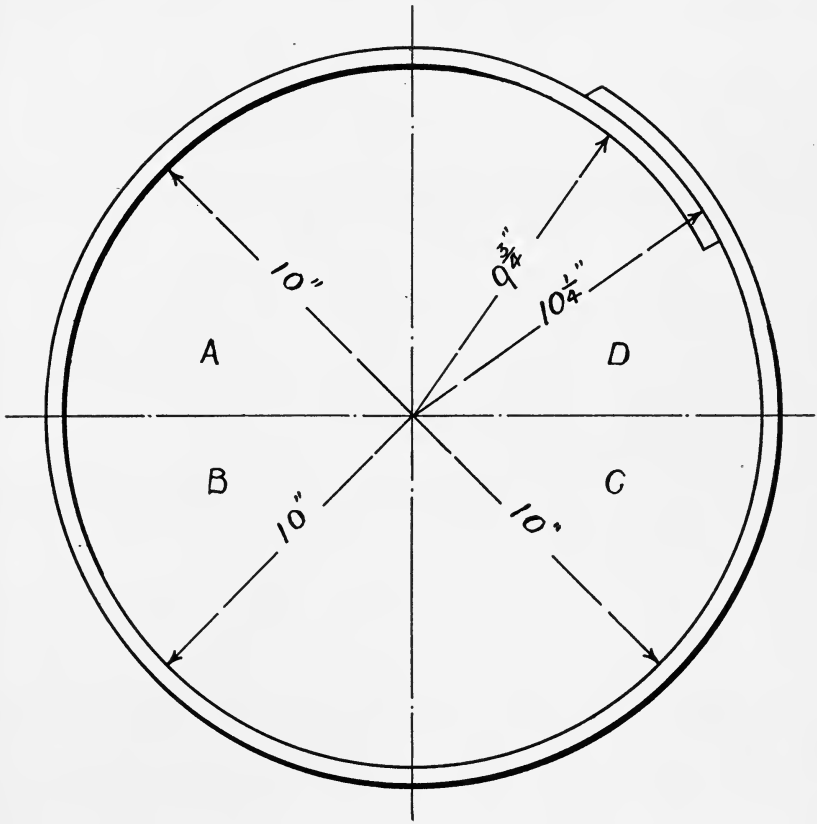
Fig. 1.

To make this point clear, let us refer to Figure One, which represents a cross-section through a shell made of boiler plate one-half inch thick, and rolled to a nominal internal radius of ten inches.

It is inevitable, therefore, that this constant bending to and fro should eventually *cause a series of cracks* to appear along the line of the rivets

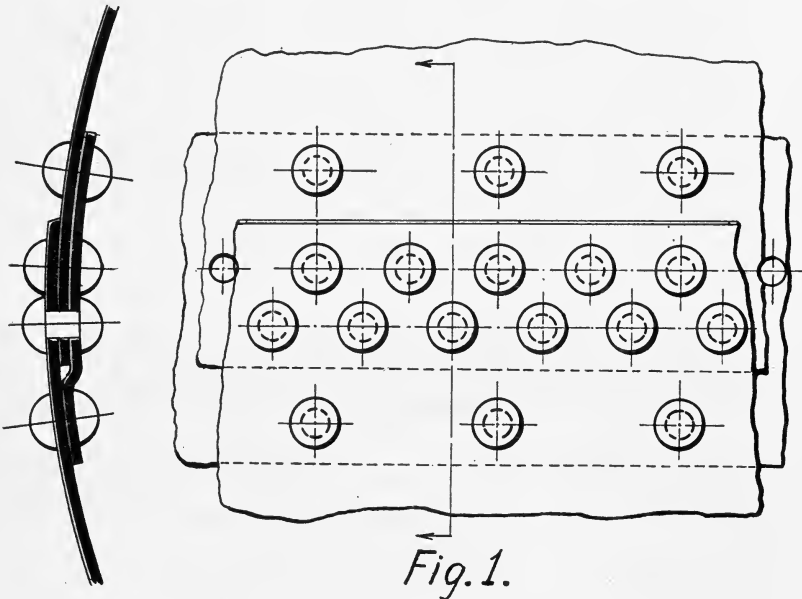
Fig. 1.
Sectional and plan view of lap joint with inside strap applied.

There is nothing new about this type of joint, as it has been known and used for many years, although it has never come into great popularity, owing to the fact that it is a mere subterfuge. In other words, while the application of an inside welt may increase the efficiency of the joint, the joint itself still remains a lap-joint, and as such it may be regarded as still subject to the development of the hidden cracks and to fatigue of

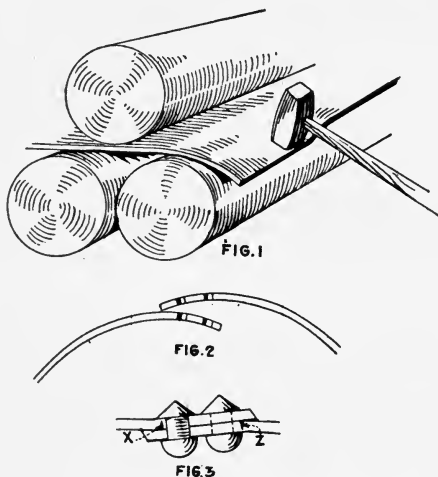
The never-ending effort of the contained pressure to perform the impossible feat of rounding out the irregular surface existing at the lap seams produces the lap-seam crack, for which this joint is notorious. In Fig. 3, x and z indicate the development of such a crack, while Fig. 5

Fig. 1. Forming end of plate over roll.
 Fig. 2. Ends of plate to be sledged to shape.
 Fig. 3. Lap seam stressed to failure.

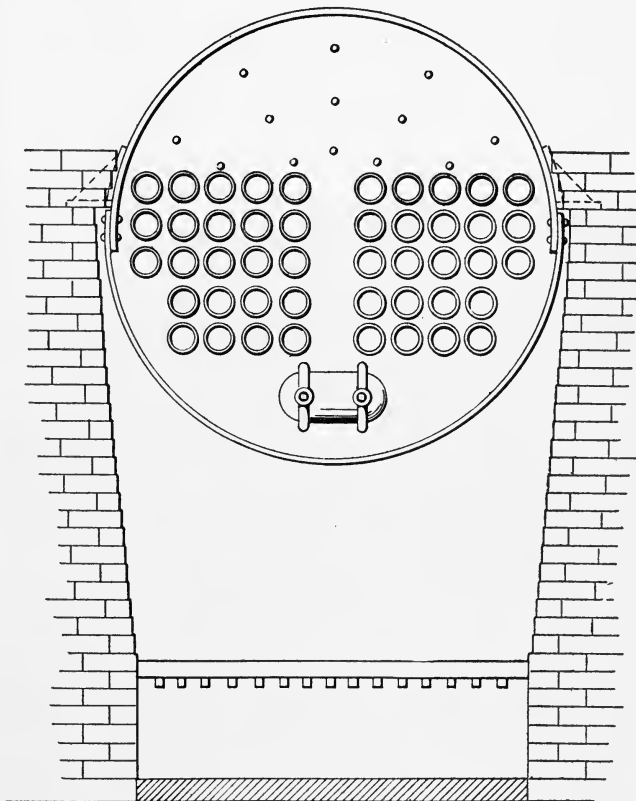
Fig. 4. Seams of single-sheet boiler inaccessible and exposed to furnace heat.

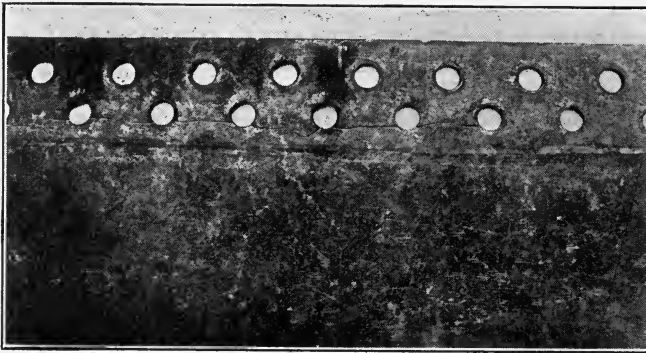
shows a crack that developed in a plate in service. Furthermore, this lack of symmetry renders the plate along the line of greatest stresses susceptible to corrosive action, which would be intensified where there were three pairs of supporting brackets, as was the case with large boilers; and the settling of the furnace walls at the front or rear transferred the load, amounting to one-half the weight of the boiler and contents, onto the center bracket.

Fig. 5. A lap-joint crack.

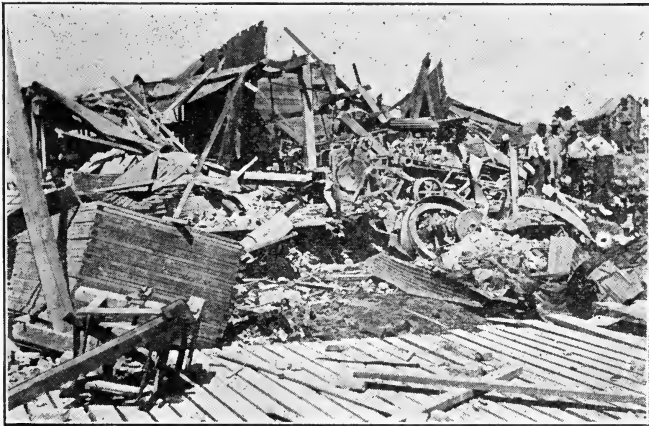
The accompanying photographs, Figs. 6 to 8, illustrate the damage done by the explosion of a single-sheet boiler, which resulted in the death of two workmen, and serious injury of two others, and the total

Fig. 6. Result from the explosion of a single-sheet boiler.

destruction of the plant. Fig. 6 gives a good idea of the general damage to the plant, and Fig. 7 is a close-up view of the boiler tubes and head. The boiler was said to have been about 24 years old, and its builder was unknown, as it had been used elsewhere and had changed owners a number of times. So far as could be learned, the boiler never had been subjected to an examination by anyone qualified to pass judgment in such matters. The double-riveted lap seams extended from the front head to the rear head on each side of the boiler. The means of support consisted of three pairs of castiron brackets resting on the furnace walls, one being between the dome and longitudinal seams, on either side of the boiler. The pressure carried at the time of the explosion was 100 lb., and it was probable the builder sold the boiler when new with the customary guarantee of that pressure, which would be permitted by a factor of safety of 4.

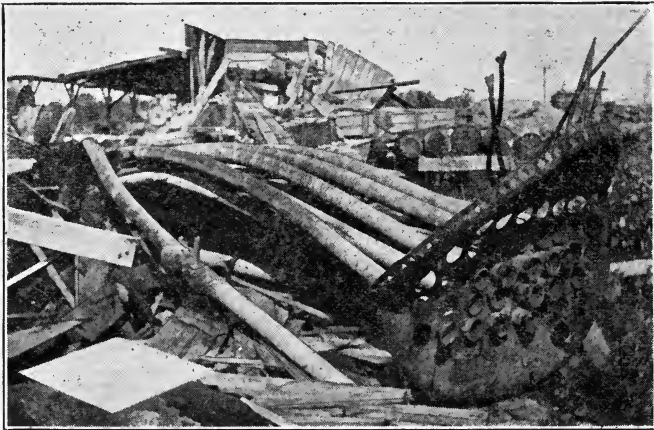
The failure occurred in the sheet forming the lower part of the boiler, on a line coinciding with the edge of the inner lap, just about the same location as in the failure of the Fargo, Tex., boiler, and did not follow nor enter the rivet holes. It extended the entire length of the seam, as is customary with violent failure of this kind. The rivets in the head

Fig. 7. Close-up view of boiler tubes and head.

seams either sheared at the junction of the plates or the rivet heads pulled off, as none of the rivet holes were destroyed, although some of them were found to be considerably elongated.

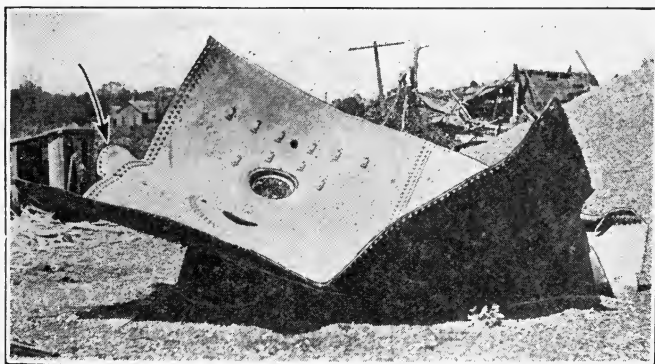
indicated by the arrow in Fig. 8, apparently without giving thought to the cause of the difficulty, but riveting the patch at the boiler seam, and using patch bolts for securing the new seam. The boiler was continued in operation without further trouble until about a week before the explosion, when seam leakage was again observed. The mill superintendent and an employee are said to have drilled and threaded for $\frac{3}{4}$ -inch capscrews, four holes along the seam where leakage had appeared. A soft patch consisting of a sheet of plow steel and a thin sheet of lead was secured to the boiler by means of capscrews and nuts, and the boiler was again placed in service.

Fig. 8. Shell plates blown free of the ends and tubes.

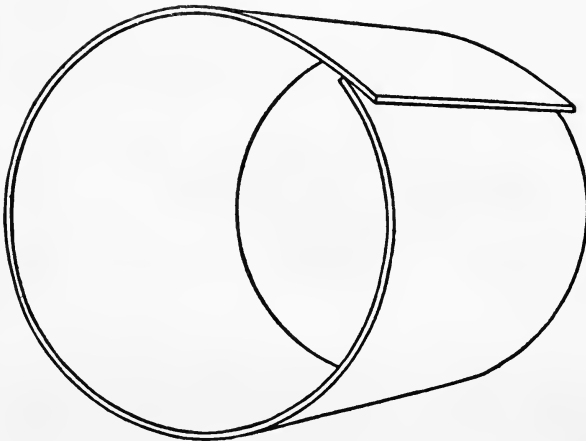
Fig. 1. When plates are rolled to a cylindrical form there is a tendency for plate edges to remain flat as in this case.

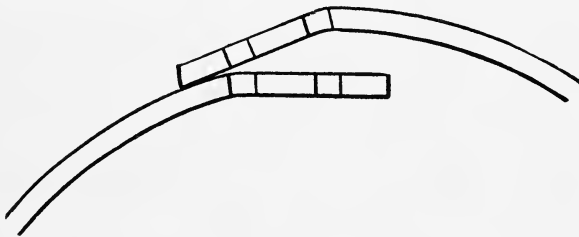
Fig. 2. If bent after punching, plates will bend along a line of rivet holes.

plate as shown at *A* the joint would be very faulty. Assuming the original joint as having the rivet holes spaced $3\frac{1}{4}$ inches and the additional holes spaced $6\frac{1}{2}$ inches, if the plate material were defective or contained a lap crack as shown, the failure of the joint would require only the shearing of the rivets in long pitch, or $6\frac{1}{2}$ inches, and the failure of the defective plate.

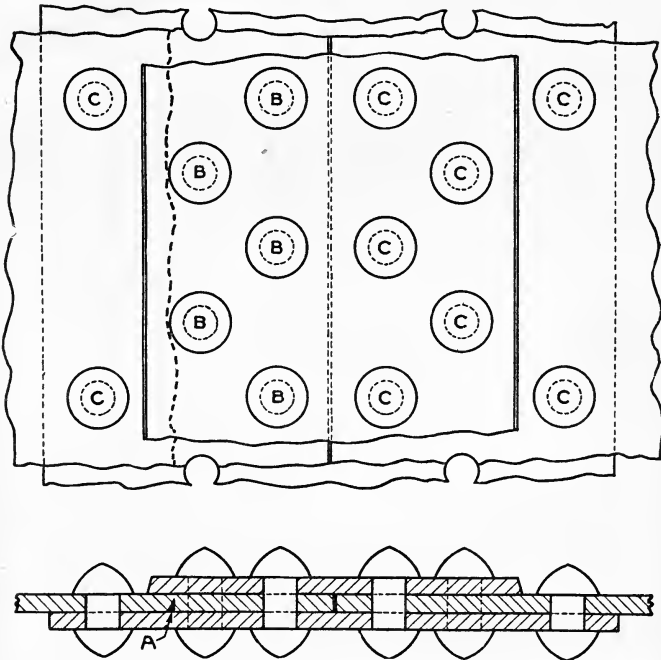
Assuming that a double riveted lap joint has been changed to a triple riveted butt construction, the joint, after placing the butt straps and riveting, would appear as shown in Fig. 5 with the rivet holes of the original lap joint at *B* and the new holes at *C*. If a defect existed in the

Fig. 5. Double riveted lap joint changed to triple riveted butt strap type.

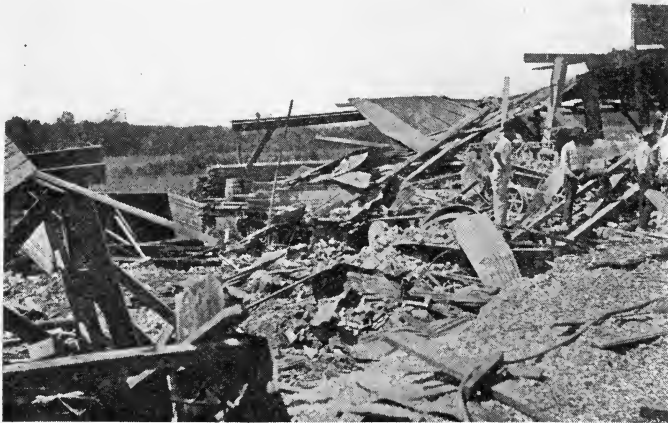
Fig. 1. Result of boiler explosion in planing mill, Antlers, Okla.

At 7:30 a.m., September 20, 1920, the town of Antlers, Okla., was shocked by the explosion of a boiler located in a planing mill at that place. The plant was totally wrecked, and two men were killed, while two others were seriously injured. The head of one of the men who were killed was completely severed from the body.

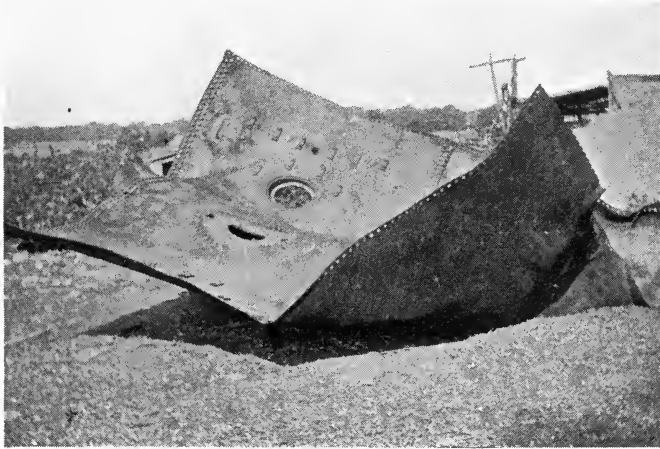
The immediate cause of the explosion was a lap seam crack, which extended from the front head to the rear head of the boiler, along the

Fig. 2. View of shell plates, showing patch and extent of crack.

longitudinal seam, and which no doubt had been years in fully developing. The complete history of the boiler was unknown, but it was said to have been purchased second hand, provided with usual safety appliances, and placed in operation at 100 pounds pressure, which was continued until leakage was observed at the longitudinal seam on the right hand side, when facing the front.

extensively with rules controlling boiler repairs. However, there is one requirement which has been almost universally adopted, which prohibits the repairing of a sheet in which a lap seam crack has developed.

The A.S.M.E. Boiler Code limits the pressure on lap seam boilers to 50 pounds after 20 years of service, and likewise prohibits repairing the sheet of a boiler in which a lap seam crack has been discovered. The loss of life and damage to property at the Antlers planing mill alone, to say nothing of the great number of similar explosions which have occurred elsewhere, clearly justifies the Code requirements, and every boiler maker called upon to tighten by calking, or repair by patching the longitudinal seam of a lap seam boiler, should refuse to make repairs until it is clearly demonstrated that a lap seam crack does not exist.

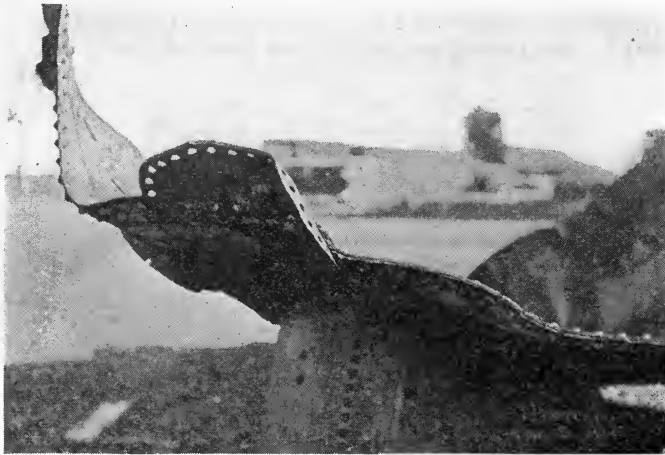
It is possible that the boiler maker who made the riveted patch repair looked with pride upon his work, for the patch was tight, and while its shape could have been improved upon, its workmanship was above the average. It is further probable he had never heard of a lap seam crack. This is a defect thousands of men are seeking daily, in order to prevent just what took place at Antlers, and if this mechanic had been thoroughly posted upon the developments which have taken place in his trade in recent years, the designs which have proven faulty, and the many failures of lap joints, due to the lap joint cracking, he could have prevented the disaster, by refusing to make repairs.

Fig. 3. Close-up view of patch and crack.
